**AREA B - EAST/WEST STREETS
EXISTING LIGHT LEVELS VERSUS
PROPOSED CRITERIA**

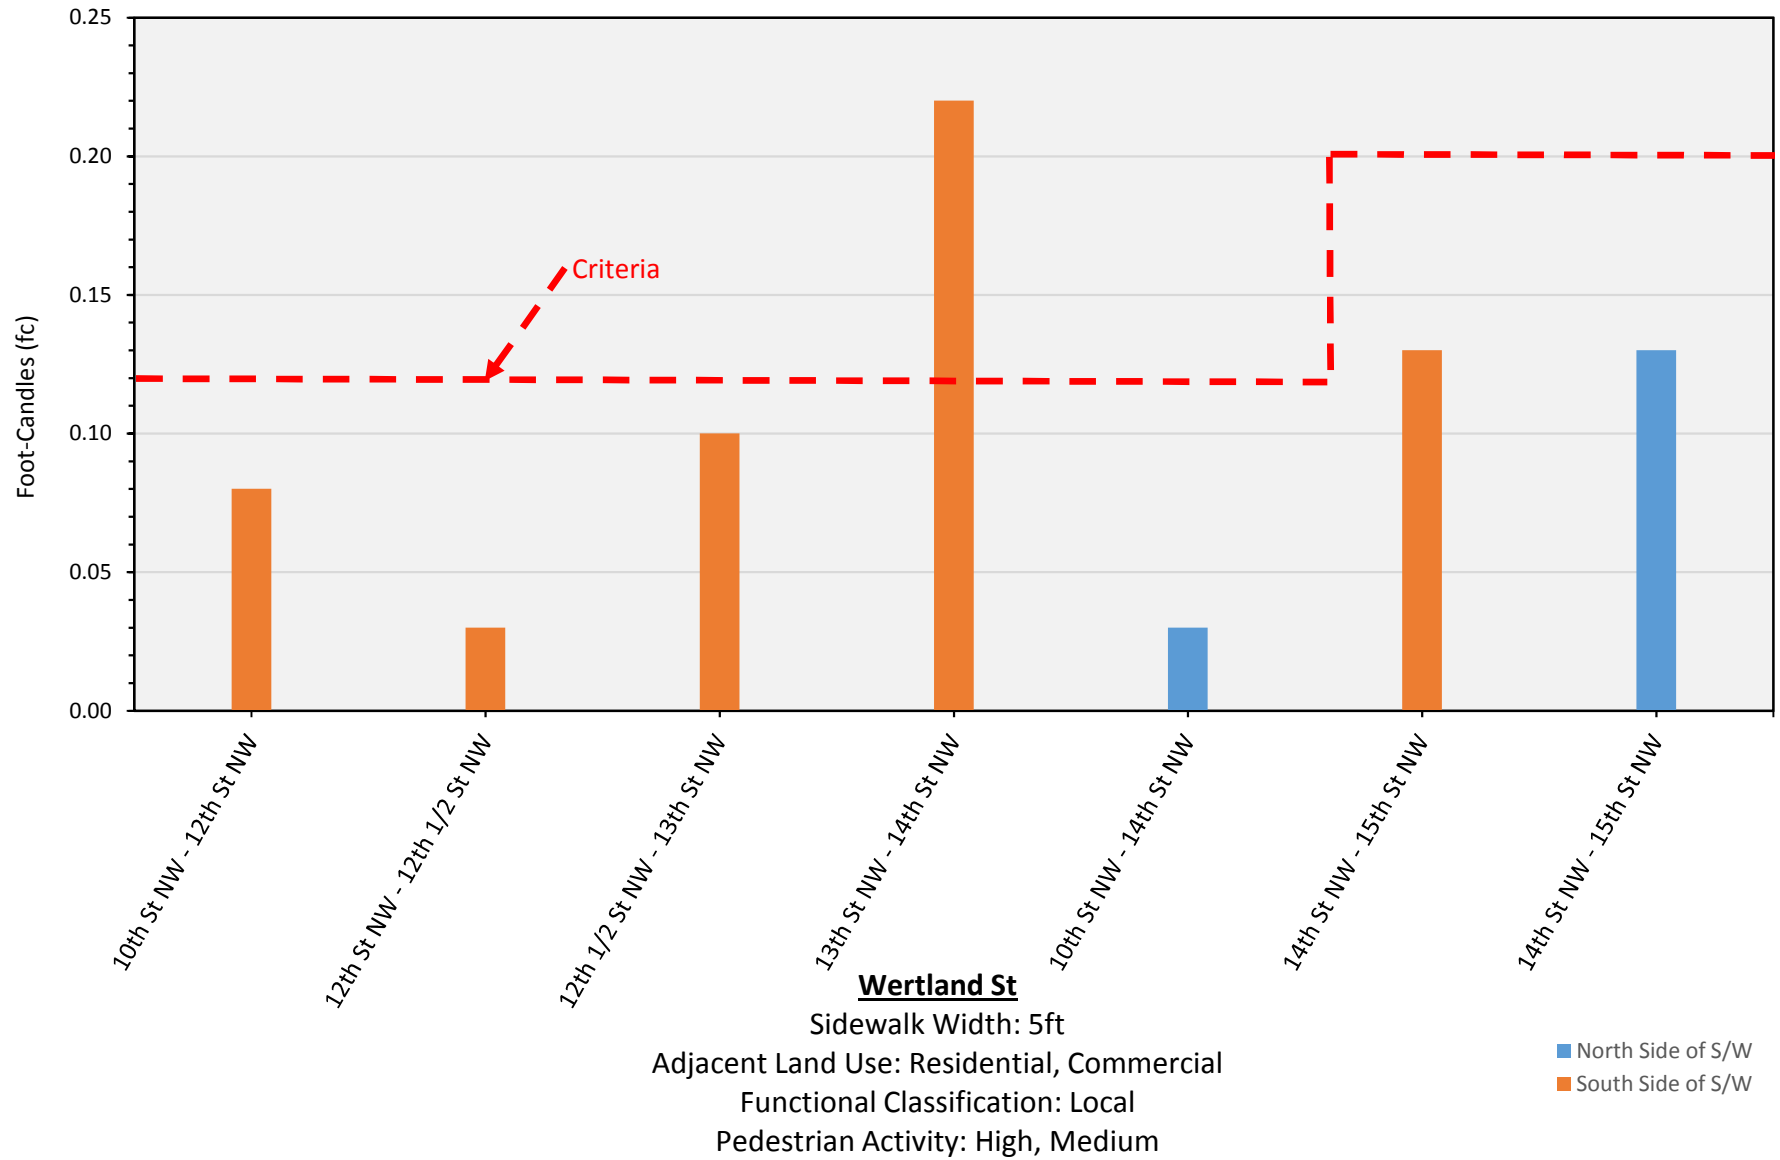
Wertland St - Eastbound Min. Vertical Illuminance from Existing Lighting

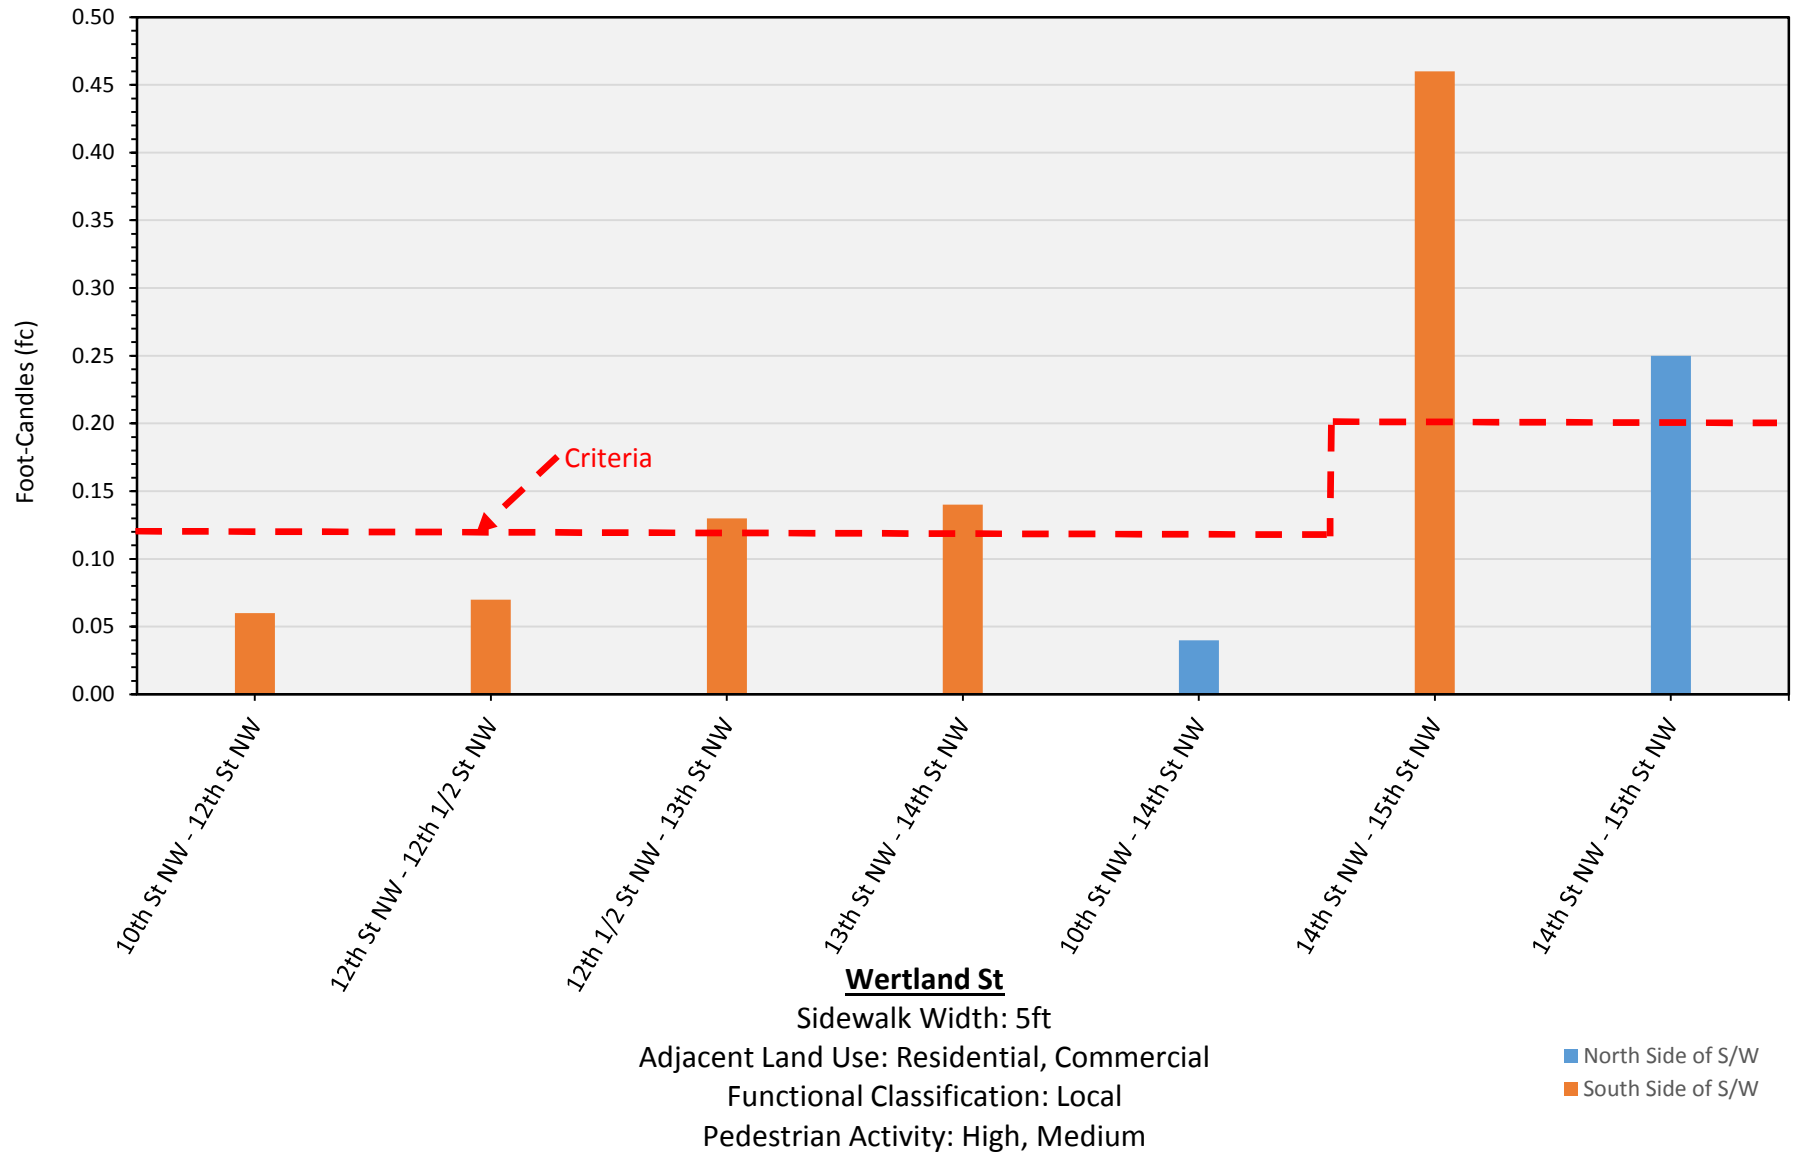
Wertland St - Westbound Min. Vertical Illuminance from Existing Lighting

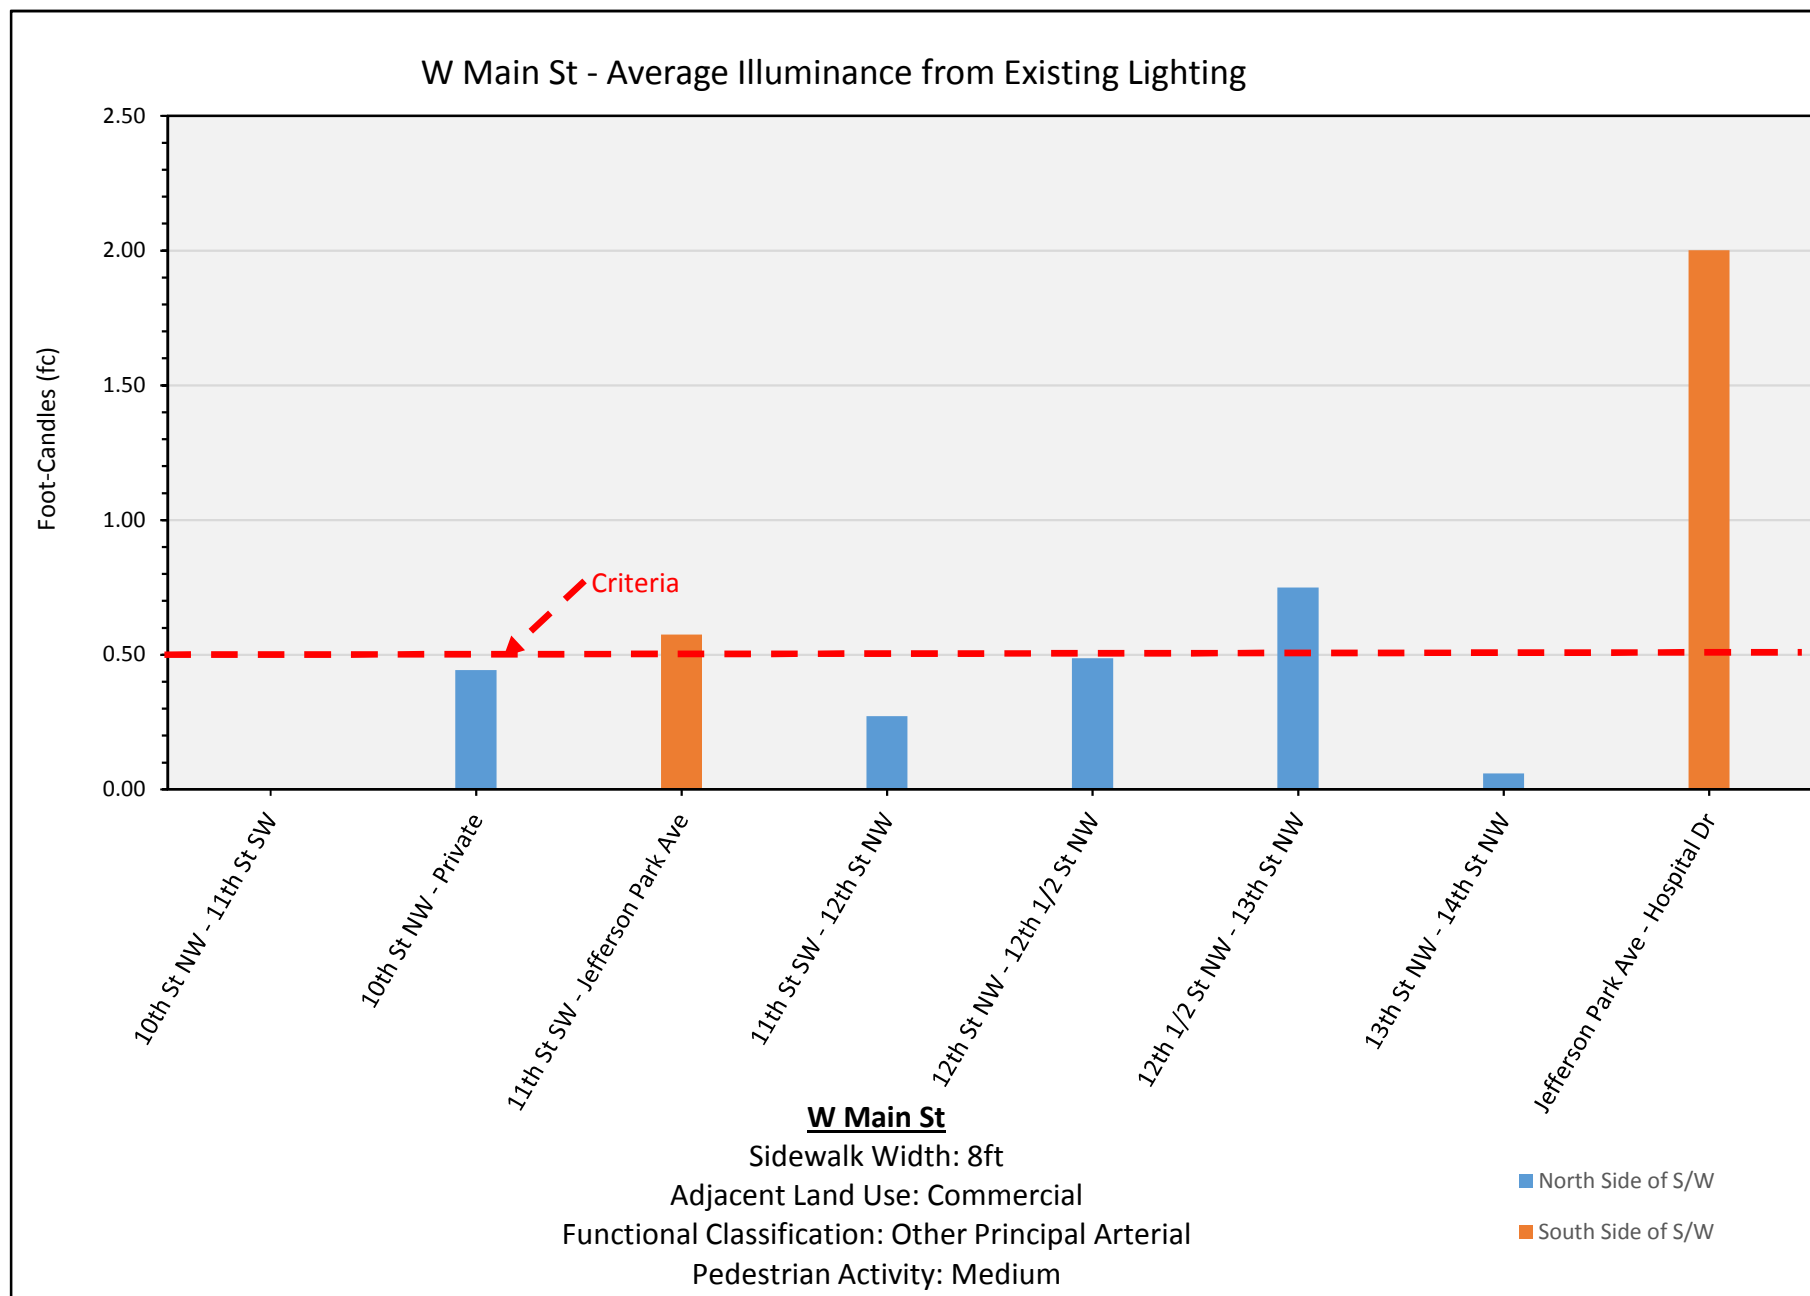
Note:

1. Where no bar is shown, average value of 0.00 fc was recorded.

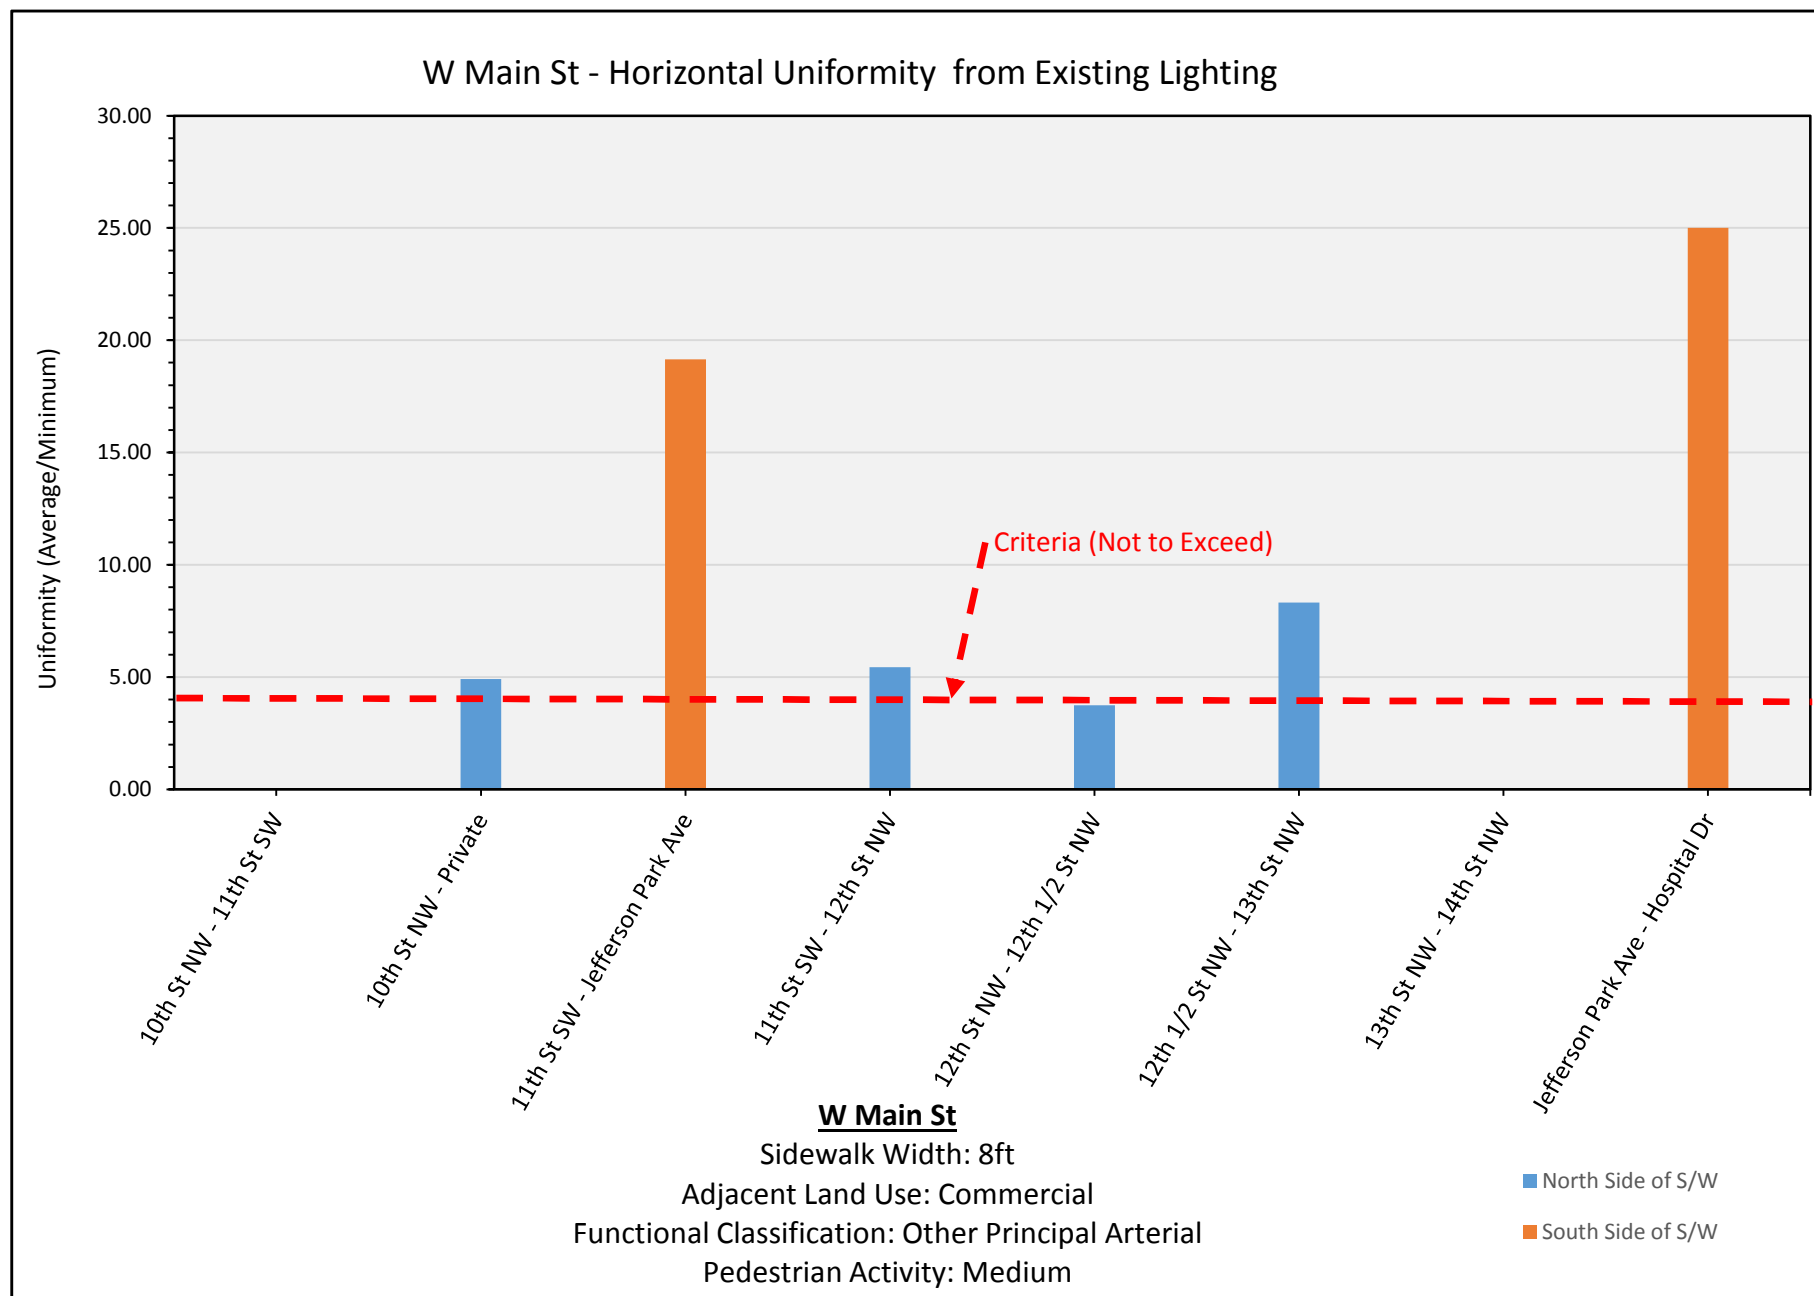
Note:

1. Where no bar is shown, uniformity (average/minimum) is not within proposed criteria and cannot be calculated due to 0.00 fc minimum.

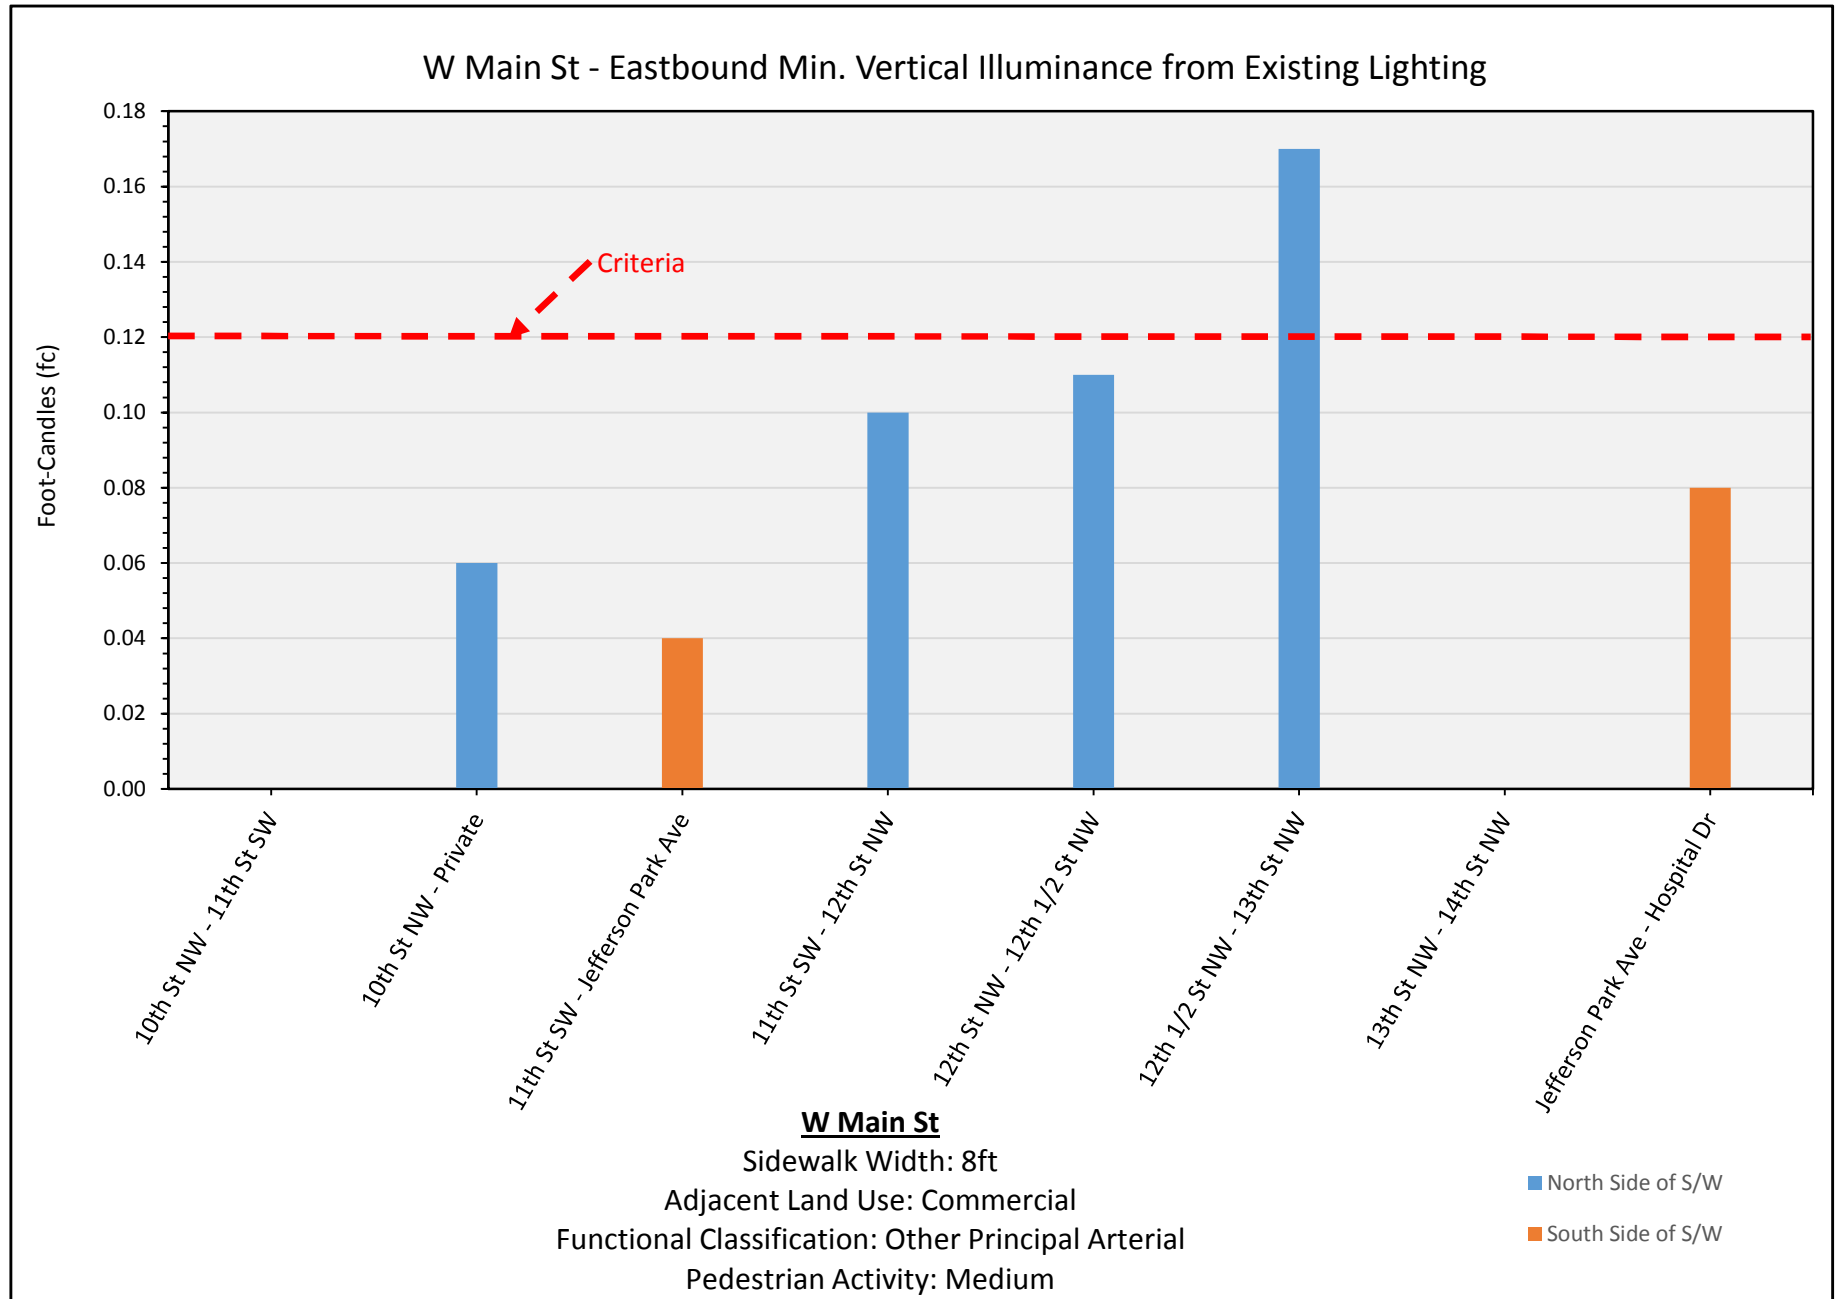
Note:

1. Where no bar is shown, minimum vertical value of 0.00 fc was recorded.

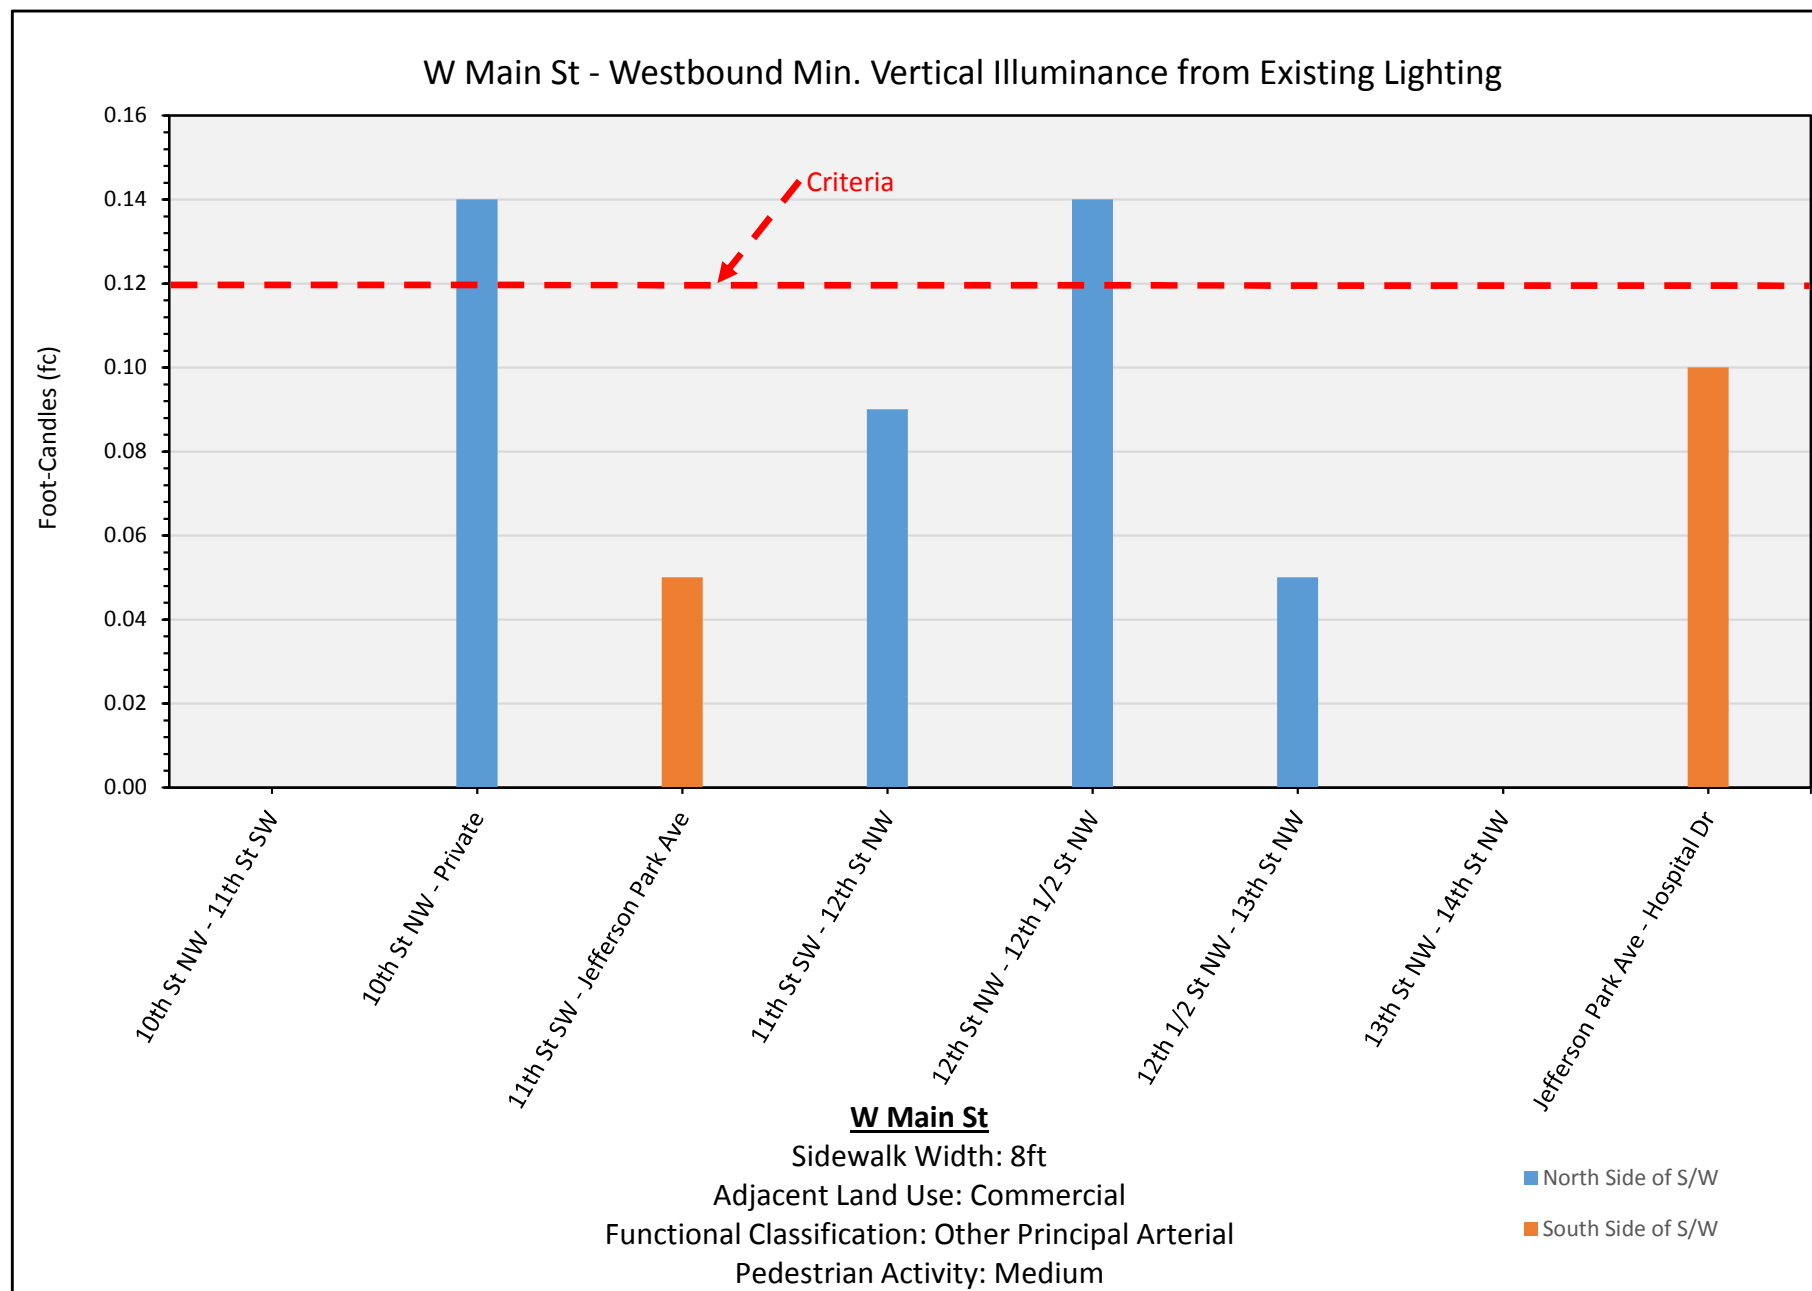
Note:

1. Where no bar is shown, minimum vertical value of 0.00 fc was recorded.

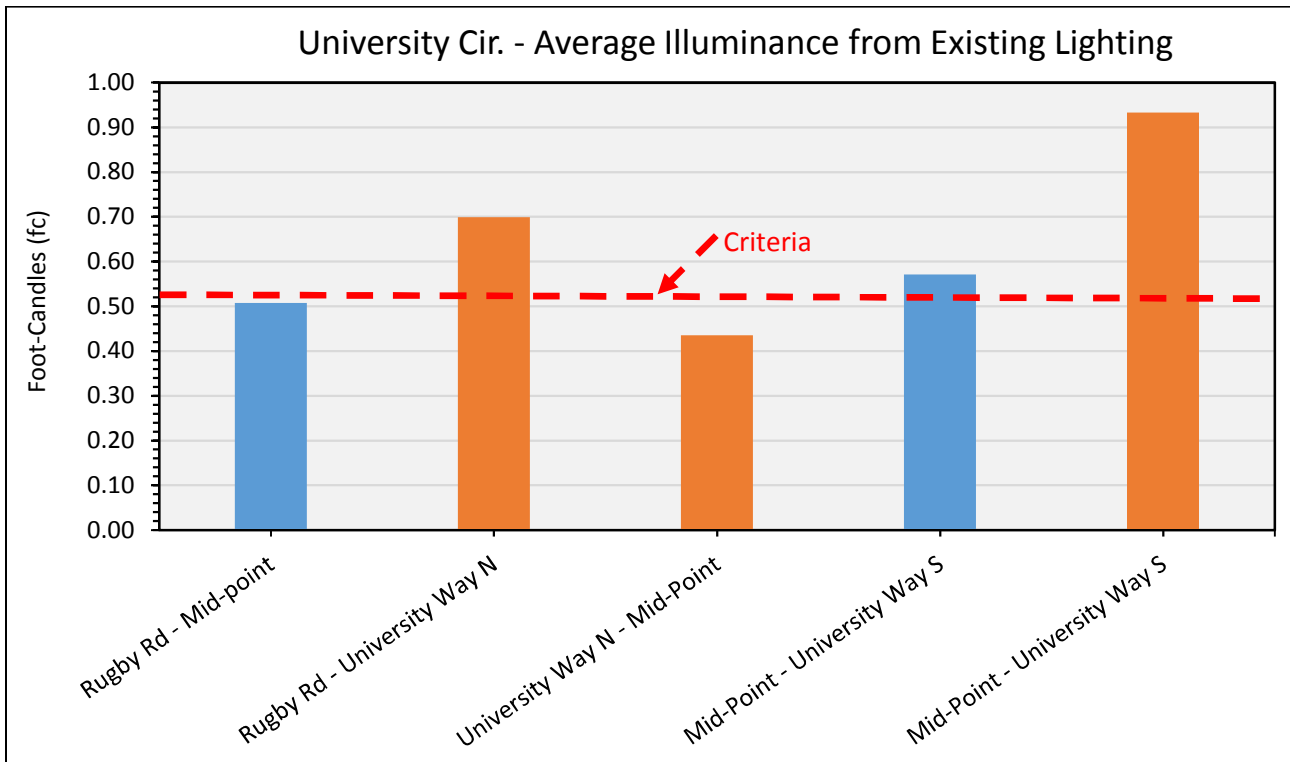
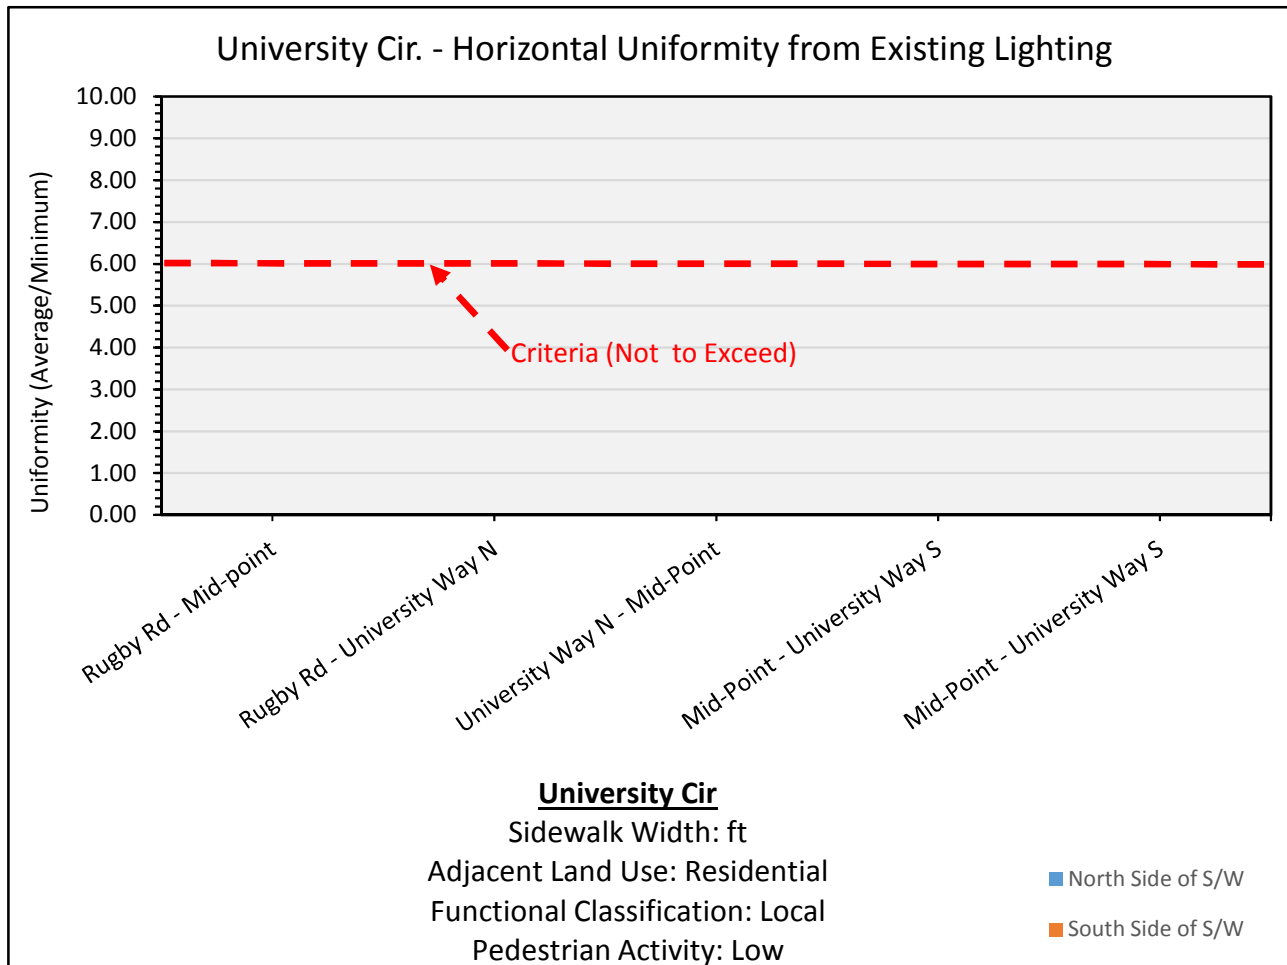
Note:

1. Where no bar is shown, average value of 0.00 fc was recorded.
2. Where no bar is shown, uniformity (average/minimum) is not within proposed criteria and cannot be calculated due to 0.00 fc minimum.

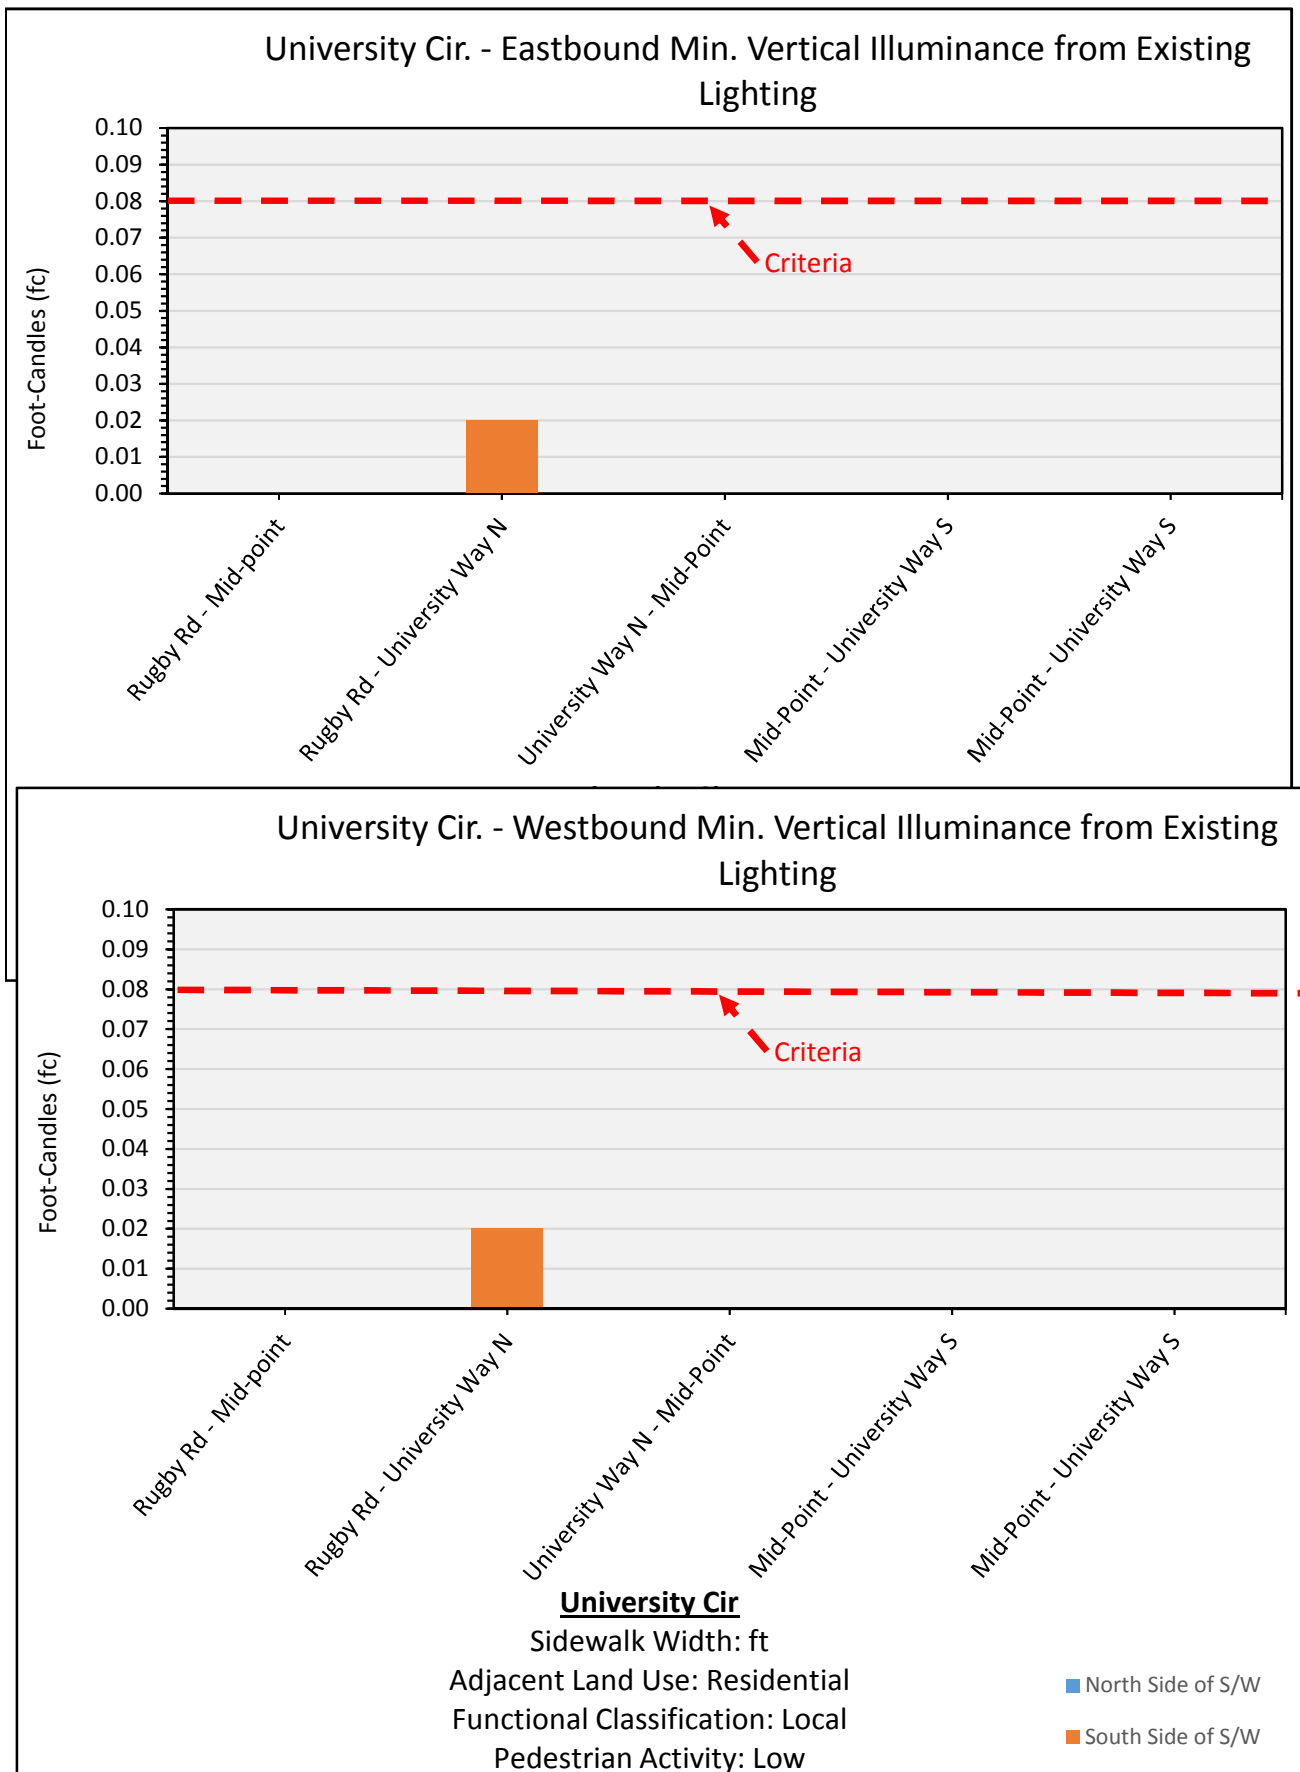
Note:

1. Where no bar is shown, minimum vertical value of 0.00 fc was recorded.

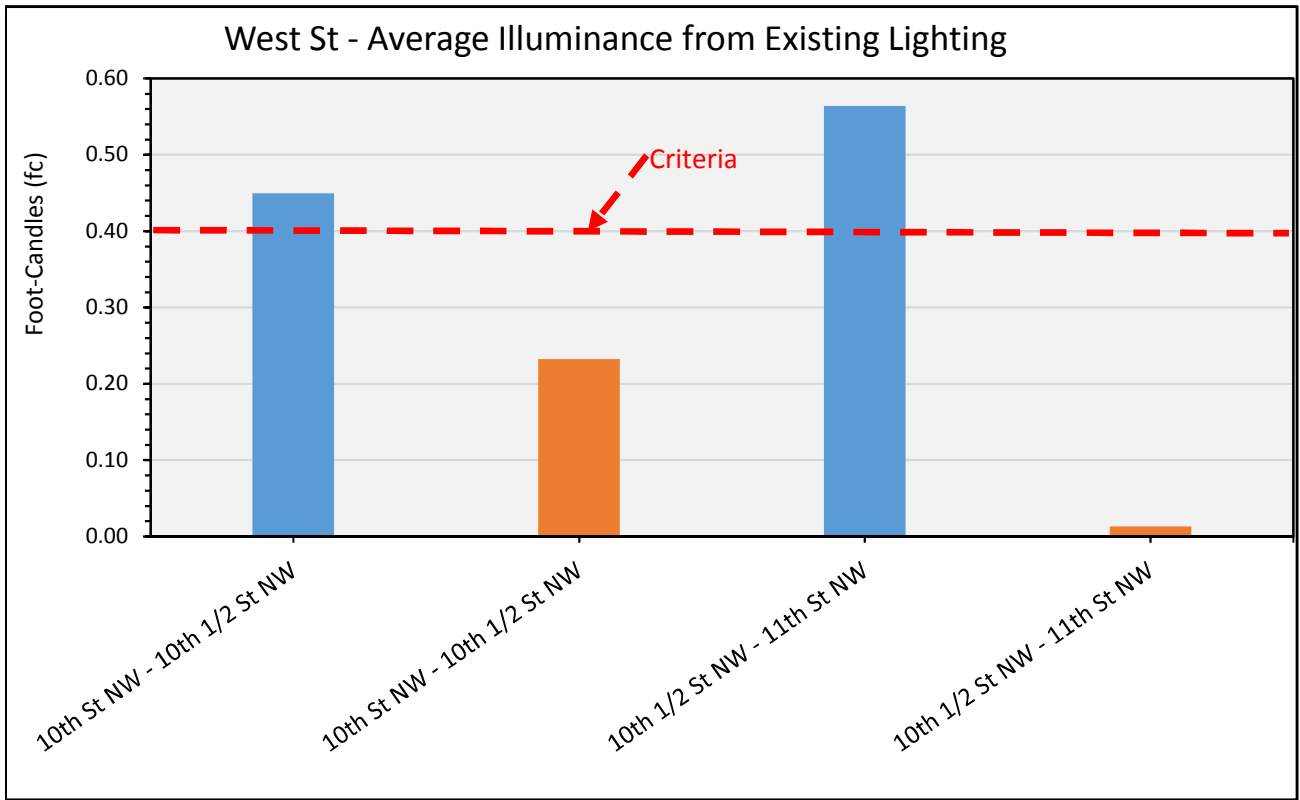
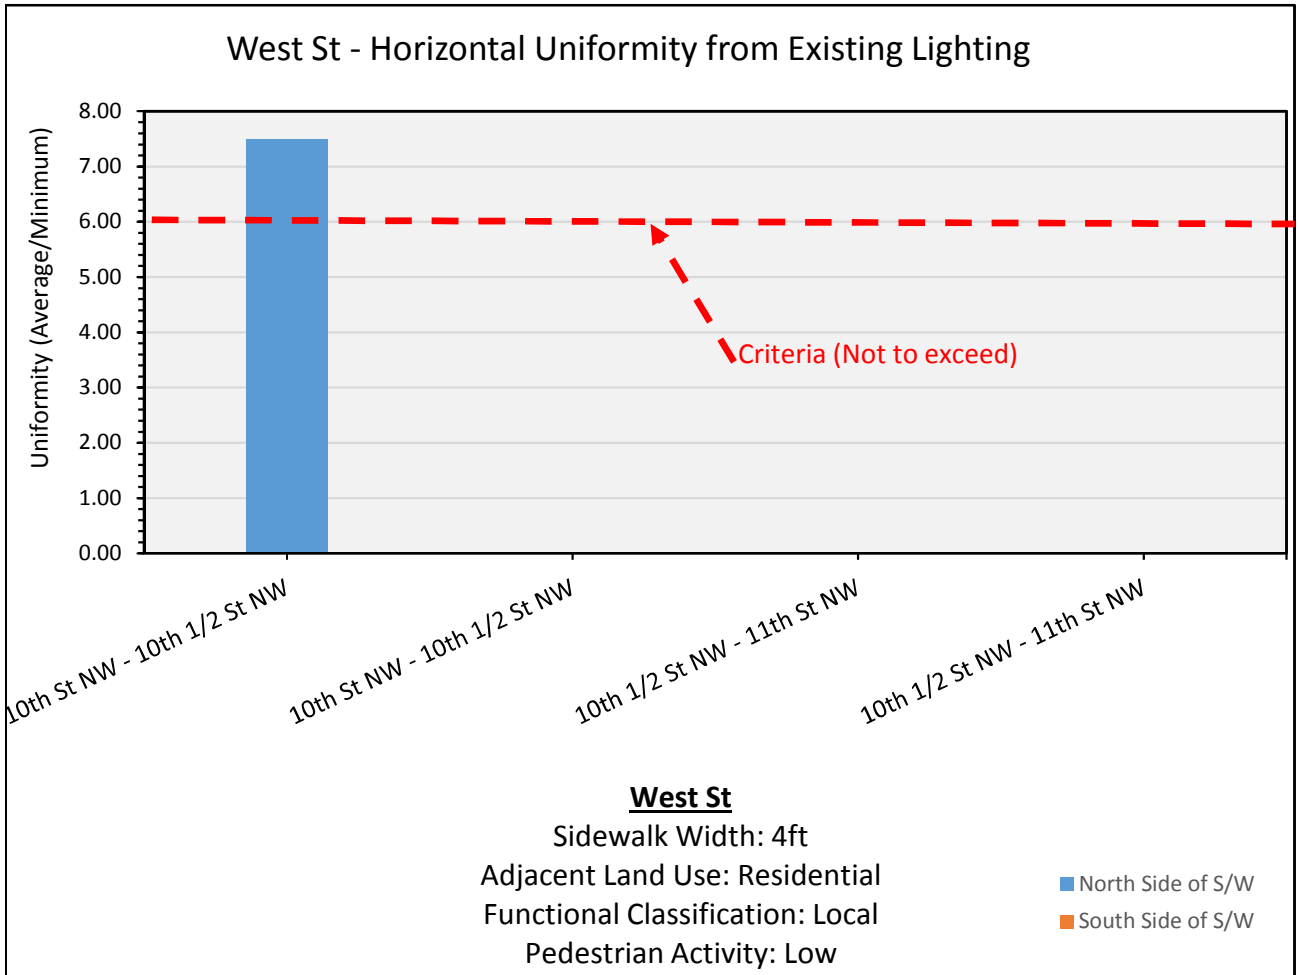
Note:

1. Where no bar is shown, Average value of 0.00 fc was recorded.
2. Where no bar is shown, uniformity (average/minimum) is not within proposed criteria and cannot be calculated due to 0.00 fc minimum.

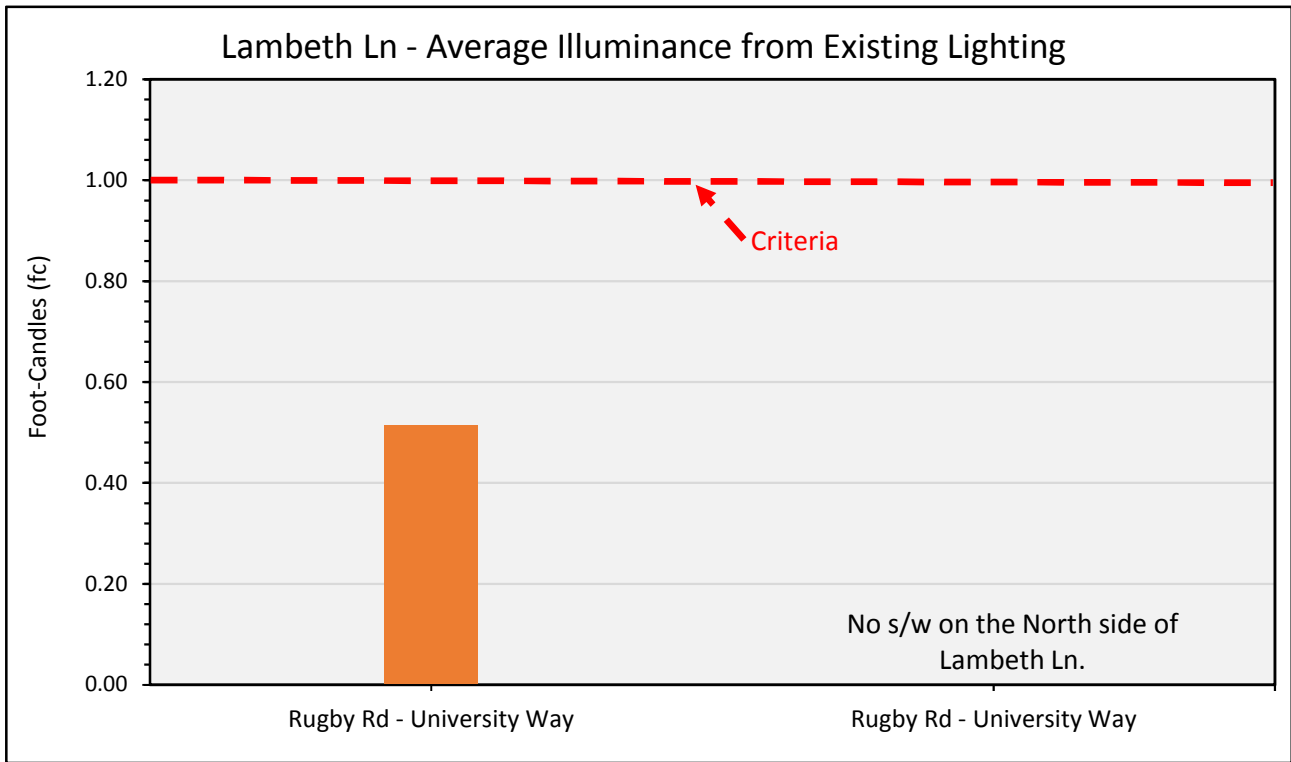
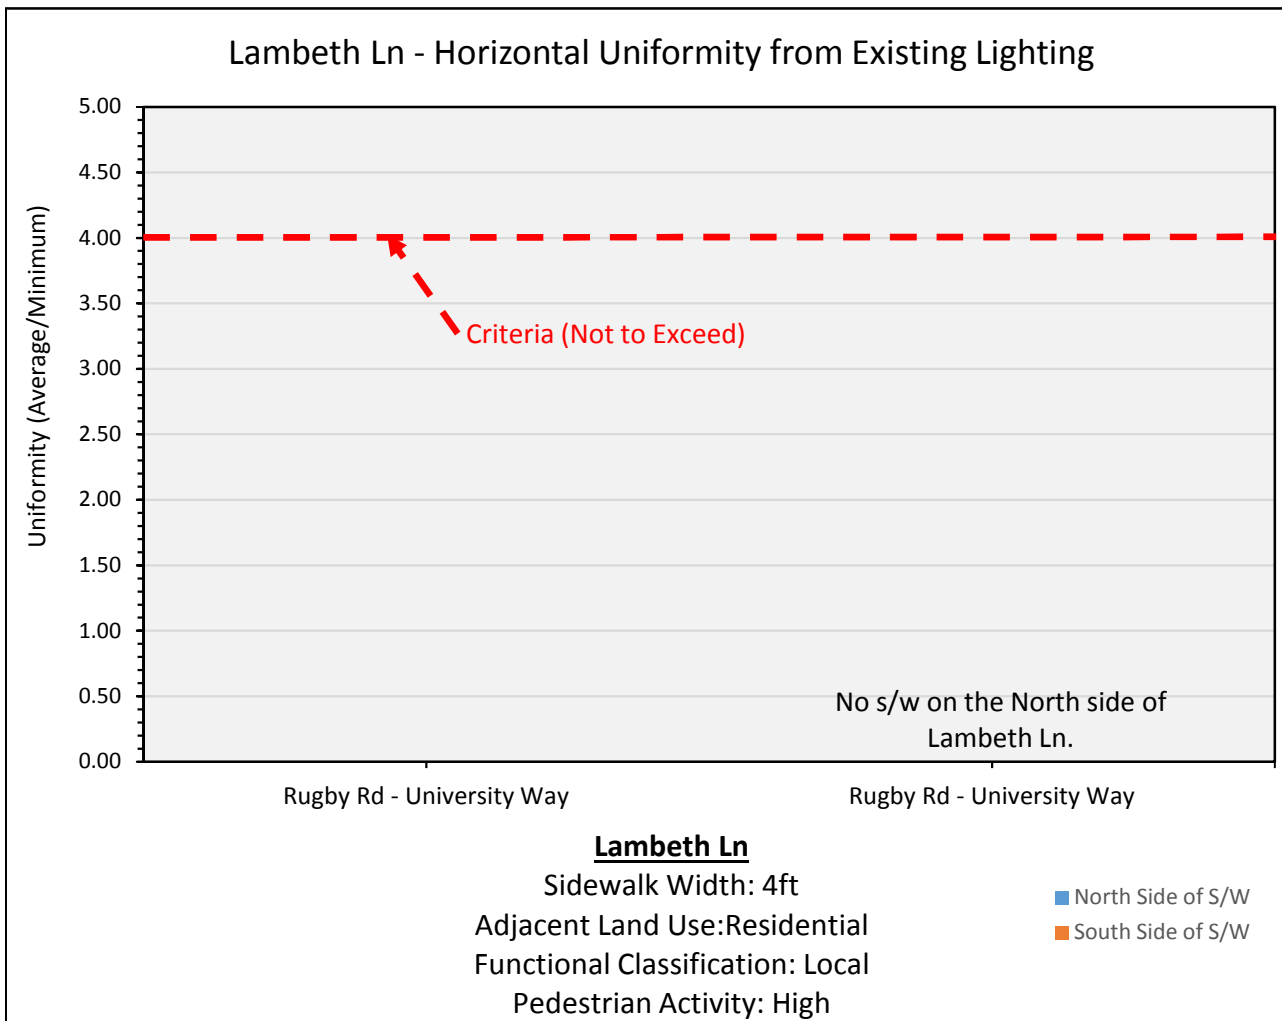
Note:

1. Where no bar is shown, average value of 0.00 fc was recorded.
2. Where no bar is shown, uniformity (average/minimum) is not within proposed criteria and cannot be calculated due to 0.00 fc minimum.
